TEST REPORT

Report No.: E6930.01-201-44

PRODUCT TYPE: In-Swing Door with Interior Lift and Tilt Blind **SERIES/MODEL**: Innovia using 8070 CL Tempered

SPECIFICATIONS: WDMA 7-14 – Cycle Slam Test AAMA 920-11- Specification for Operating Cycle Performance of Side-Hinged Exterior Door Systems

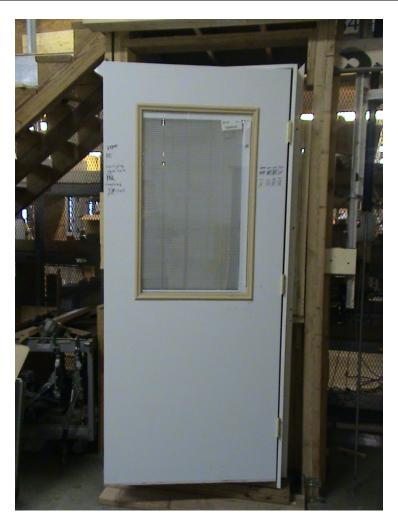
Overall Area:	Width		Height	
2.1 m ² (22.4 ft ²)	millimeters	inches	millimeters	inches
Overall size	956	37-5/8	2178	85-3/4
Leaf size	908	35-3/4	2115	83-1/4
